Suzanne Avila
Los Altos Hills Community Development Department
263790 Fremont Road
Los Altos Hills, CA 94022

June 27, 2014

27299 Byrne Park Lane, condition of coast live oak tree #8

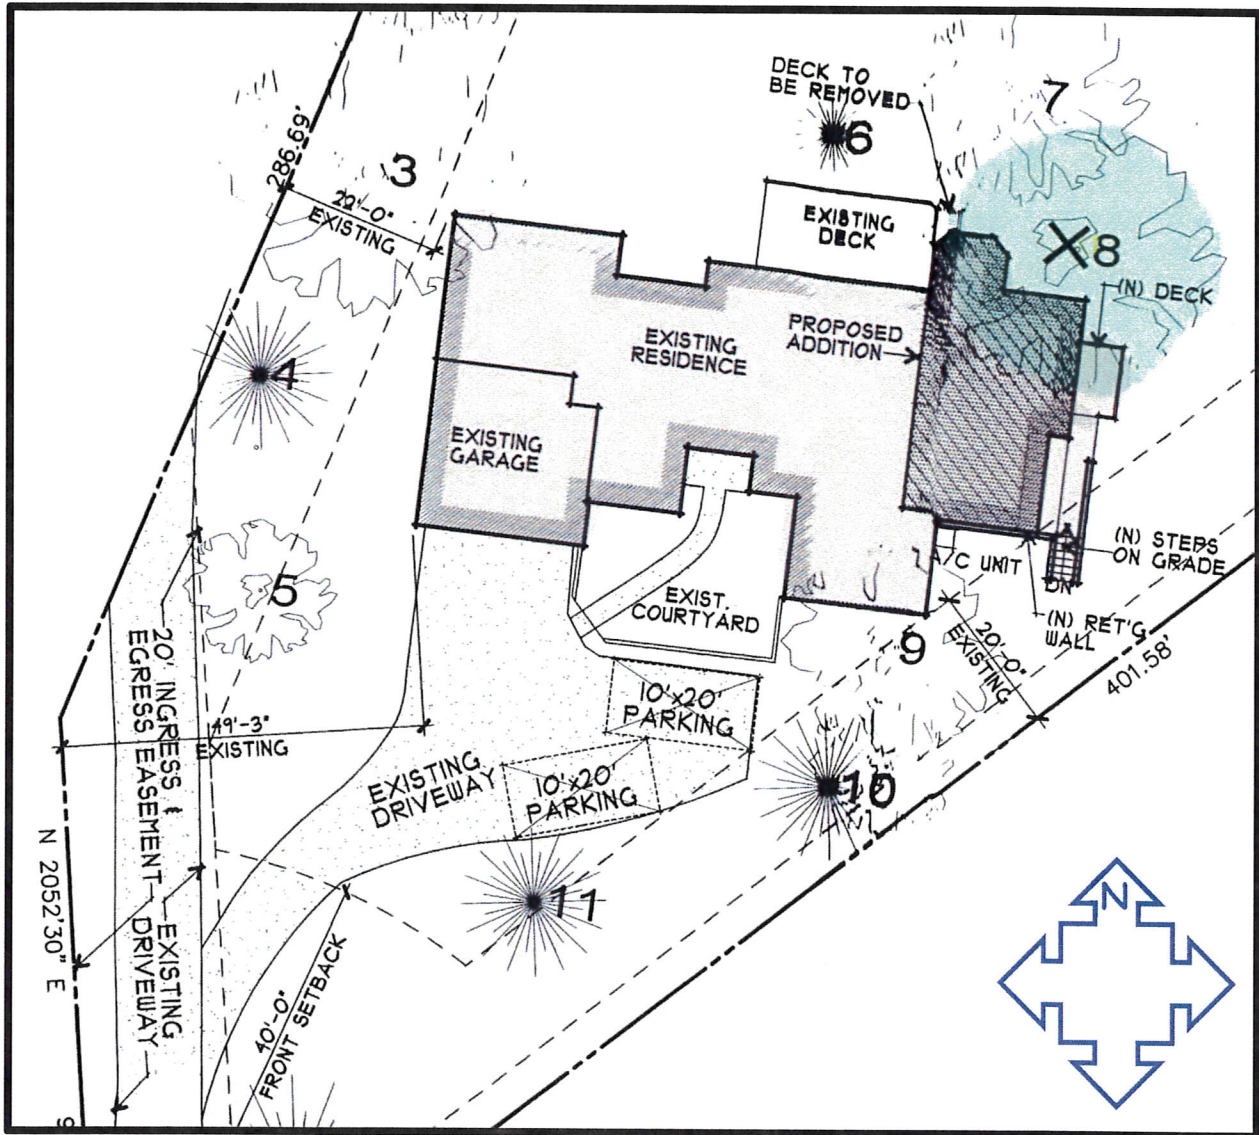
A portion of the Site Plan in the construction plan set I received is shown above. I have highlighted the subject oak, which is labeled as tree #8. Based upon the plans it appears that the North side of the addition is about 6 feet from the trunk, and the west portion is 8 feet. These distances are approximate however, and may actually be a bit farther because the tree is on a slope below the existing house. Excavation for the addition however, can be expected to extend a few feet beyond the actual wall of the addition. So, if the tree may remain I think it would be a good idea to actually survey the location of the addition (and also note any necessary over-excavation beyond the addition) relative to this tree.

- a) A distance of 8 linear feet is recommended as a minimum no soil disturbance zone from the edge of the trunk of this tree. If this distance cannot be achieved, I would lean toward removing the tree. This is the 5xDBH distance for this tree, which will experience soil disturbance on two sides of its trunk. It may be possible to squeeze down over-excavation margins in order to achieve this distance, or redesign the addition to move construction slightly farther from the tree.

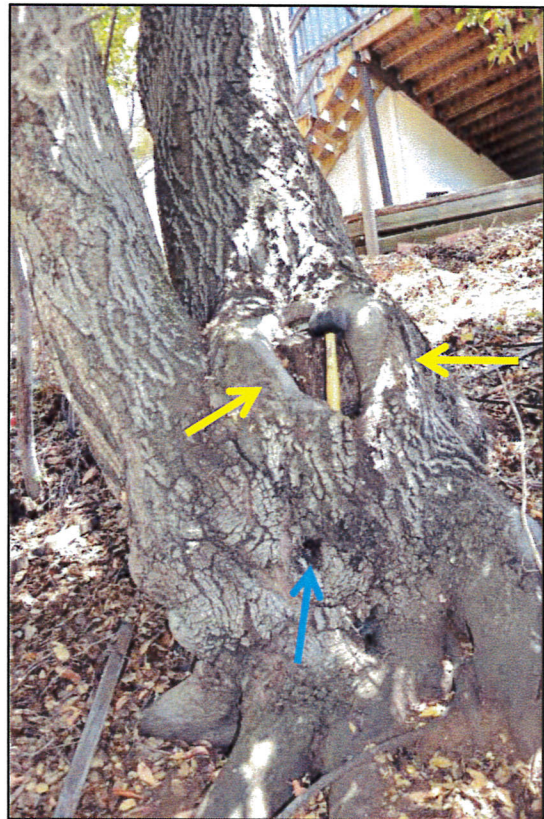
Notes: There is a large cavity in the lower portion of the larger trunk. It looks like this cavity is the result of a previous third trunk removal long ago. The cavity is at least 14 inches deep and 12 by 8 inches wide, and there is decayed wood beyond that. On a positive note though, there is very good **woundwood** growth around the cavity opening (*yellow arrows in photo at right*), which strengthens this void in the trunk. The extent of the cavity and its impact on the structural integrity of the tree cannot be accurately assessed without additional and more detailed evaluation such as **tomography** or **resistance drill** tests. The owners may contact me if interested in this type of additional evaluation.

There are some other anomalies on the lower trunk, such as an old stump or perhaps a previous fourth small trunk which is now decayed and being engulfed by the living trunk of the tree. There is also an indentation below the cavity (blue arrow in photo on previous page) which is probably an old branch stub with seems to be connected to the cavity.

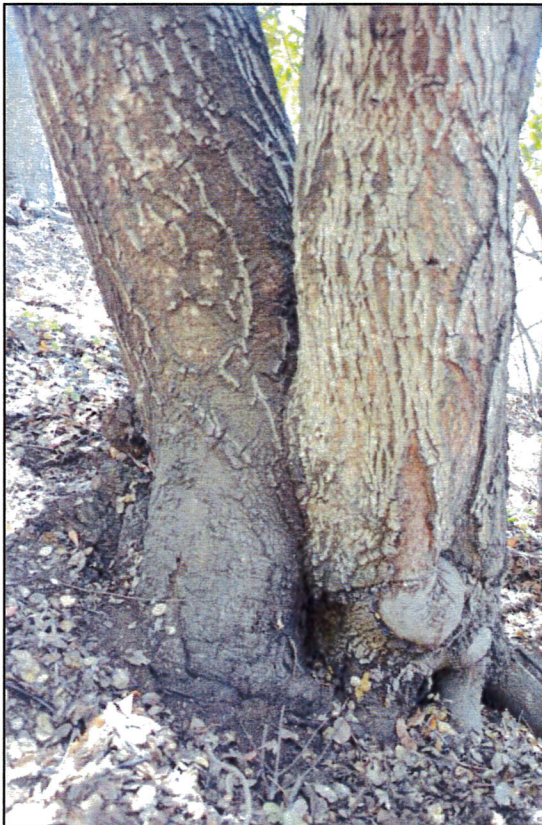
Another significant structural defect is **included bark** between the two tightly pressed together trunks, even though one trunk is quite a bit larger than the other. **Canopy density** is sparser than normal as if the tree is declining. There is also some terminal twig **dieback** and several dead branches to 3 inches in diameter.

The southeast side of the tree, showing the tightly pressed trunks with included bark between them. This side of the tree is opposite the large cavity shown in the photo on the previous page.

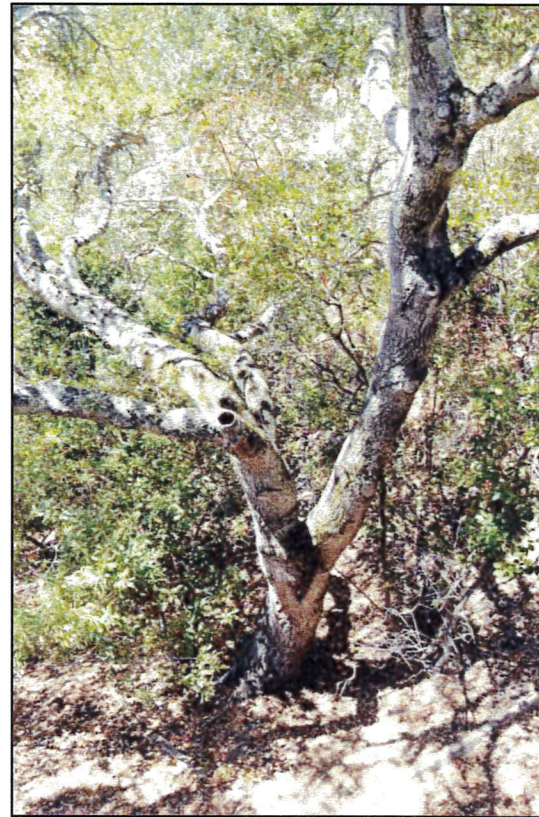
The west side of the oak, viewed from the existing deck. Some of the small cavities on branches are visible.

Regarding the branch structure of the oak, this tree has been **lion-tail pruned** in the past, which unfortunately is not unusual for oaks (and many other tree species) in this area. Long ago many flush **cut** wounds were created during pruning, some of which have decayed and developed into small to medium-size cavities on the branches.
