Suzanne Avila
Los Altos Hills Community Development Department
263790 Fremont Road
Los Altos Hills, CA 94022

June 27, 2014

27299 Byrne Park Lane, condition of coast live oak tree #8

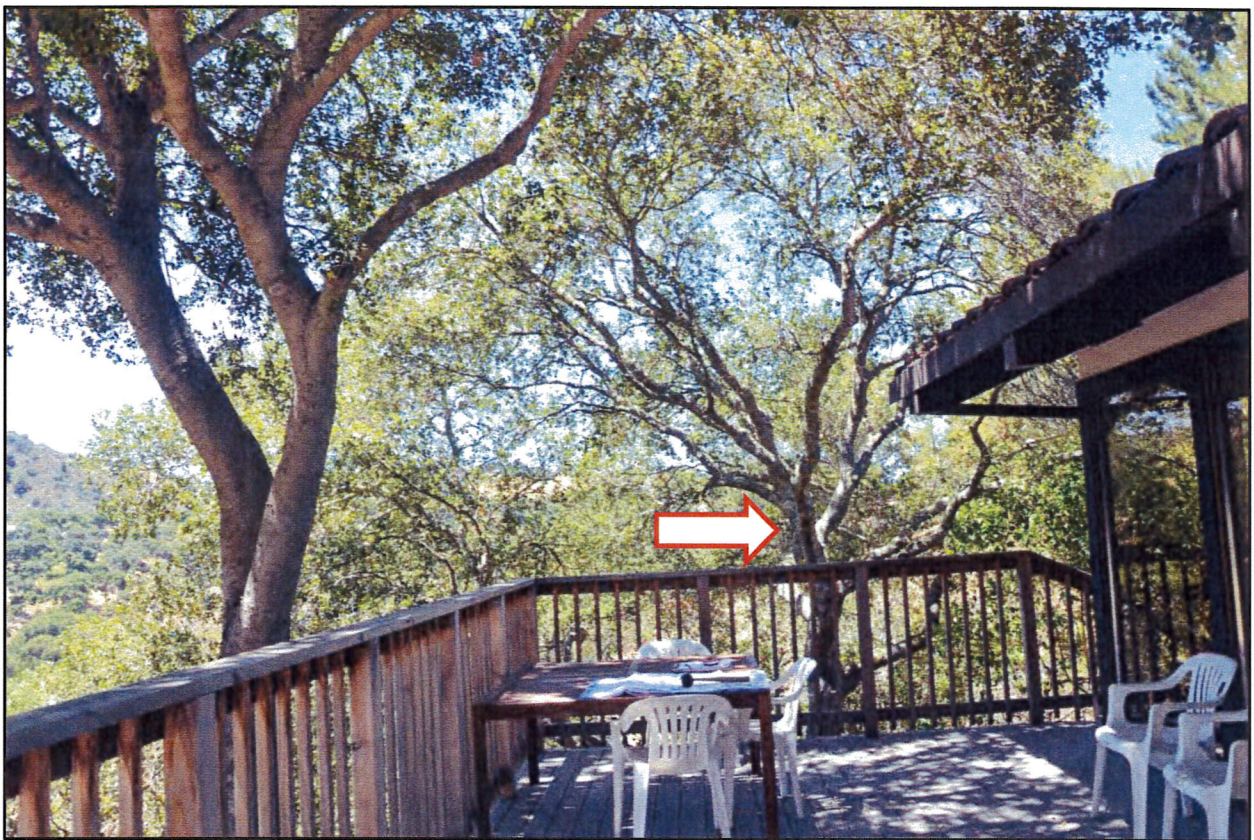
You requested that I evaluate the subject coast live oak tree, because it has been scheduled for removal on the proposed construction plans for an addition near the tree. I looked at this oak yesterday. In my opinion the tree has "Fair/Poor" preservation suitability and the proposed addition is closer than advisable to the trunk. It is possible that the addition could be constructed without severe damage to the tree, if construction work is done very carefully around the oak and the tree is adequately fenced off from construction. Whether or not to save the tree however, is debatable due to its condition. I don't think it is unreasonable to remove the tree. On the other hand it would also not be unreasonable to try to save the oak if it will not incur severe construction damage.

Notes: There is a large cavity in the lower portion of the larger trunk. It looks like this cavity is the result of a previous third trunk removal long ago. The cavity is at least 14 inches deep and 12 by 8 inches wide, and there is decayed wood beyond that. On a positive note though, there is very good **woundwood** growth around the cavity opening (*yellow arrows in photo at right*), which strengthens this void in the trunk. The extent of the cavity and its impact on the structural integrity of the tree cannot be accurately assessed without additional and more detailed evaluation such as **tomography** or **resistance drill** tests. The owners may contact me if interested in this type of additional evaluation.

Another significant structural defect is **included bark** between the two tightly pressed together trunks, even though one trunk is quite a bit larger than the other. **Canopy density** is sparser than normal as if the tree is declining. There is also some terminal twig **dieback** and several dead branches to 3 inches in diameter.

There are some other anomalies on the lower trunk, such as an old stump or perhaps a previous fourth small trunk which is now decayed and being engulfed by the living trunk of the tree. There is also an indentation below the cavity (blue arrow in photo on previous page) which is probably an old branch stub with seems to be connected to the cavity.

- a) A distance of 8 linear feet is recommended as a minimum no soil disturbance zone from the edge of the trunk of this tree. If this distance cannot be achieved, I would lean toward removing the tree. This is the 5xDBH distance for this tree, which will experience soil disturbance on two sides of its trunk. It may be possible to squeeze down over-excavation margins in order to achieve this distance, or redesign the addition to move construction slightly farther from the tree.

- b) Irrigation of the tree is recommended. Because the tree is on a slope, **water jet irrigation** (without fertilizer added) is recommended. Water jet probe holes should be spaced 2 feet on center, underneath the uncovered soil beneath the dripline of the tree, starting 3 feet from the trunk. Have the irrigation performed as soon as possible, and also irrigate the tree monthly throughout the remainder of the normal dry season, which normally extends through Mid-October. The owner may contact me for a paper with directions for the water jetting, and also a company that will provide this service.
