TOWN OF LOS ALTOS HILLS  
Staff Report to the Planning Commission

SUBJECT:    CONDITIONAL DEVELOPMENT PERMIT AND SETBACK VARIANCE  
              FOR AN ADDITION AND REMOVAL OF A HERITAGE OAK TREE;  
              LANDS OF MATHUR; 27299 BYRNE PARK LANE; FILE #140-14-ZP-SD-  
              CDP-VAR

**27299 Byrne Park Lane, condition of coast live oak tree #8**

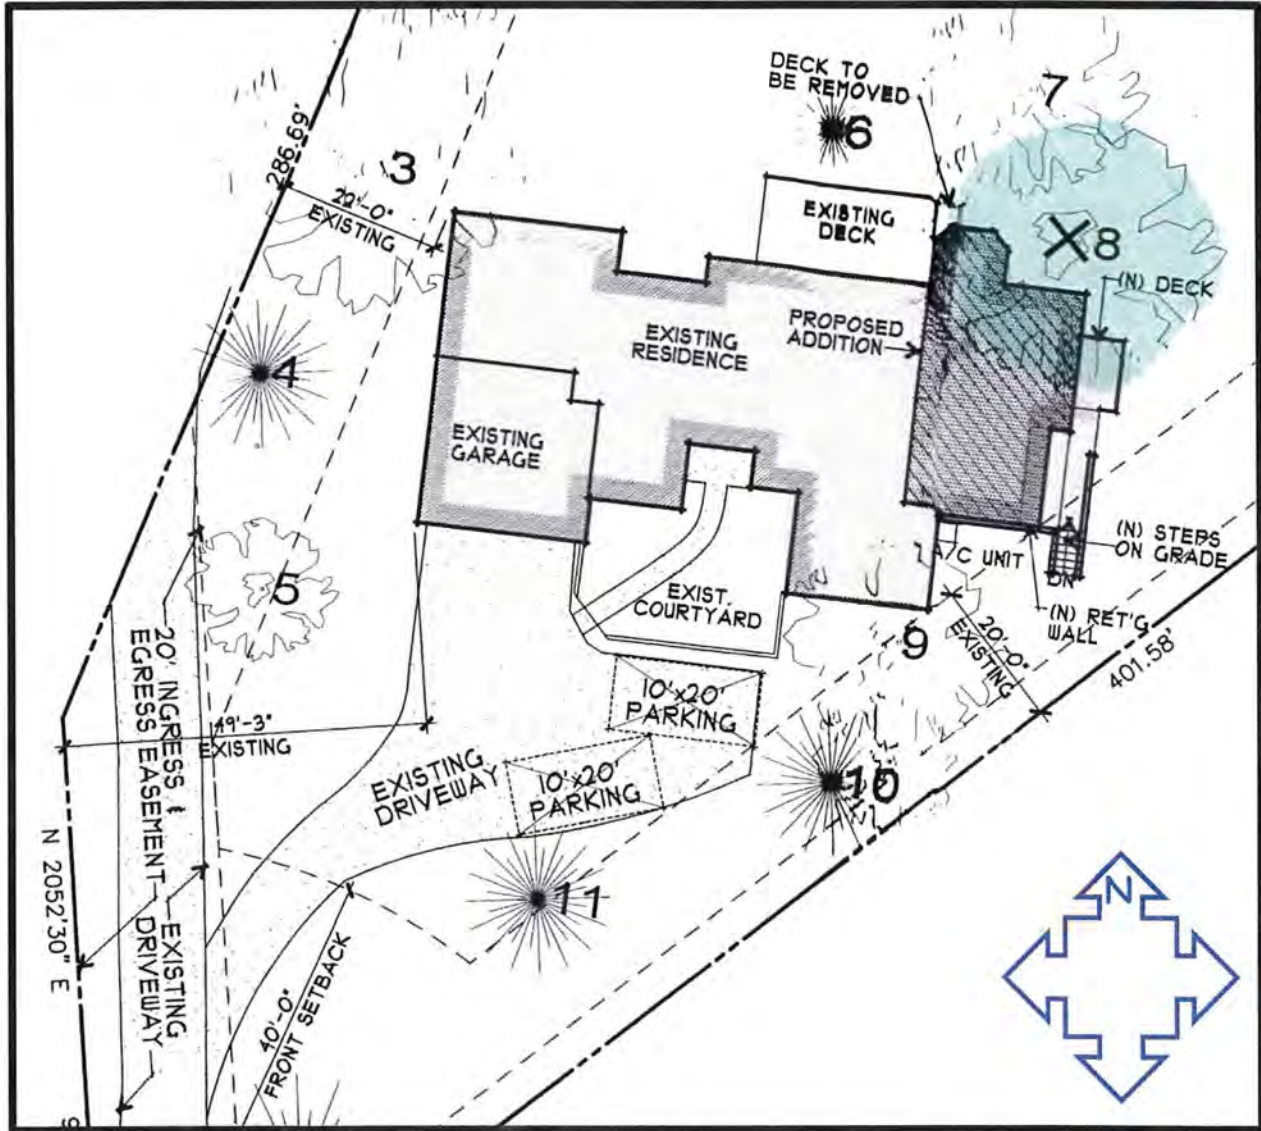
A portion of the Site Plan in the construction plan set I received is shown above. I have highlighted the subject oak, which is labeled as tree #8. Based upon the plans it appears that the North side of the addition is about 6 feet from the trunk, and the west portion is 8 feet. These distances are approximate however, and may actually be a bit farther because the tree is on a slope below the existing house. Excavation for the addition however, can be expected to extend a few feet beyond the actual wall of the addition. So, if the tree may remain I think it would be a good idea to actually survey the location of the addition (and also note any necessary over-excavation beyond the addition) relative to this tree.

- a) A distance of 8 linear feet is recommended as a minimum no soil disturbance zone from the edge of the trunk of this tree. If this distance cannot be achieved, I would lean toward removing the tree. This is the 5xDBH distance for this tree, which will experience soil disturbance on two sides of its trunk. It may be possible to squeeze down over-excavation margins in order to achieve this distance, or redesign the addition to move construction slightly farther from the tree.

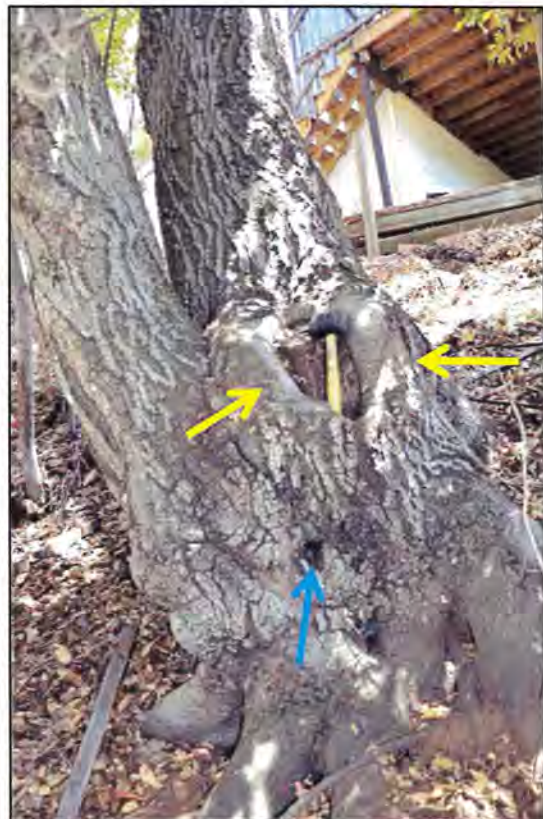
**Notes:** There is a large cavity in the lower portion of the larger trunk. It looks like this cavity is the result of a previous third trunk removal long ago. The cavity is at least 14 inches deep and 12 by 8 inches wide, and there is decayed wood beyond that. On a positive note though, there is very good **woundwood** growth around the cavity opening (*yellow arrows in photo at right*), which strengthens this void in the trunk. The extent of the cavity and its impact on the structural integrity of the tree cannot be accurately assessed without additional and more detailed evaluation such as **tomography** or **resistance drill** tests. The owners may contact me if interested in this type of additional evaluation.

There are some other anomalies on the lower trunk, such as an old stump or perhaps a previous fourth small trunk which is now decayed and being engulfed by the living trunk of the tree. There is also an indentation below the cavity (blue arrow in photo on previous page) which is probably an old branch stub with seems to be connected to the cavity.

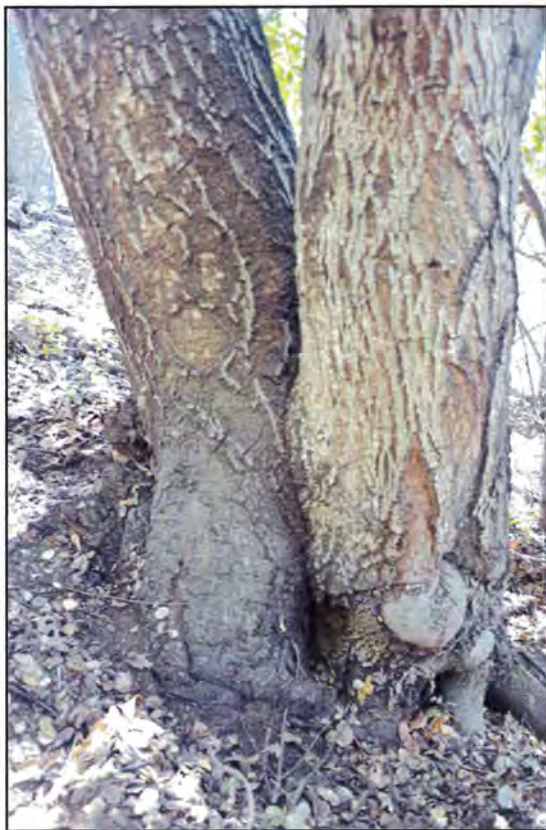
The southeast side of the tree, showing the tightly pressed trunks with included bark between them. This side of the tree is opposite the large cavity shown in the photo on the previous page.

Another significant structural defect is **included bark** between the two tightly pressed together trunks, even though one trunk is quite a bit larger than the other. **Canopy density** is sparser than normal as if the tree is declining. There is also some terminal twig **dieback** and several dead branches to 3 inches in diameter.

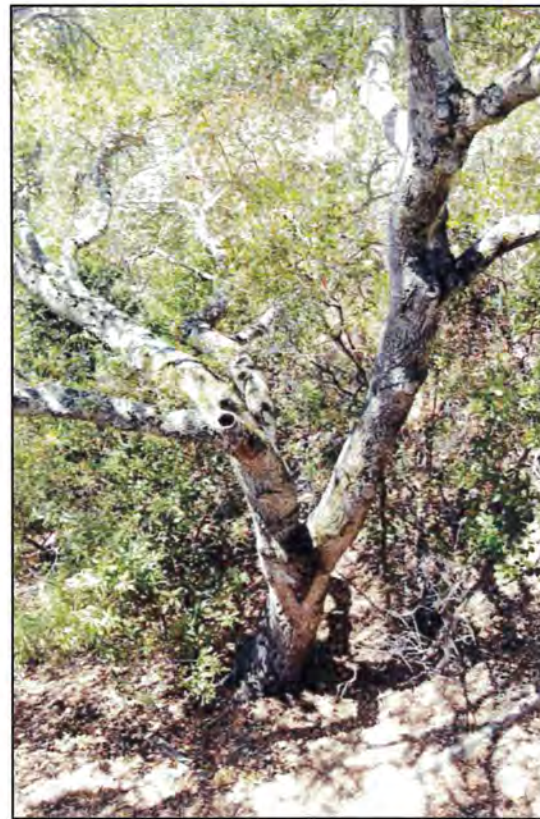
The west side of the oak, viewed from the existing deck. Some of the small cavities on branches are visible.

Regarding the branch structure of the oak, this tree has been **lion-tail pruned** in the past, which unfortunately is not unusual for oaks (and many other tree species) in this area. Long ago many flush **cut** wounds were created during pruning, some of which have decayed and developed into small to medium-size cavities on the branches.
